PETROLEUM PRODUCTS STORAGE
HAI PHONG, NORTH VIETNAM
2052N 10639E

THIS BRIEFING BOARD DEPICTS STRIKE DAMAGE TO HAI PHONG PETROLEUM PRODUCTS STORAGE.

PETROLEUM PRODUCTS STORAGE

HAI PHONG, NORTH VIETNAM

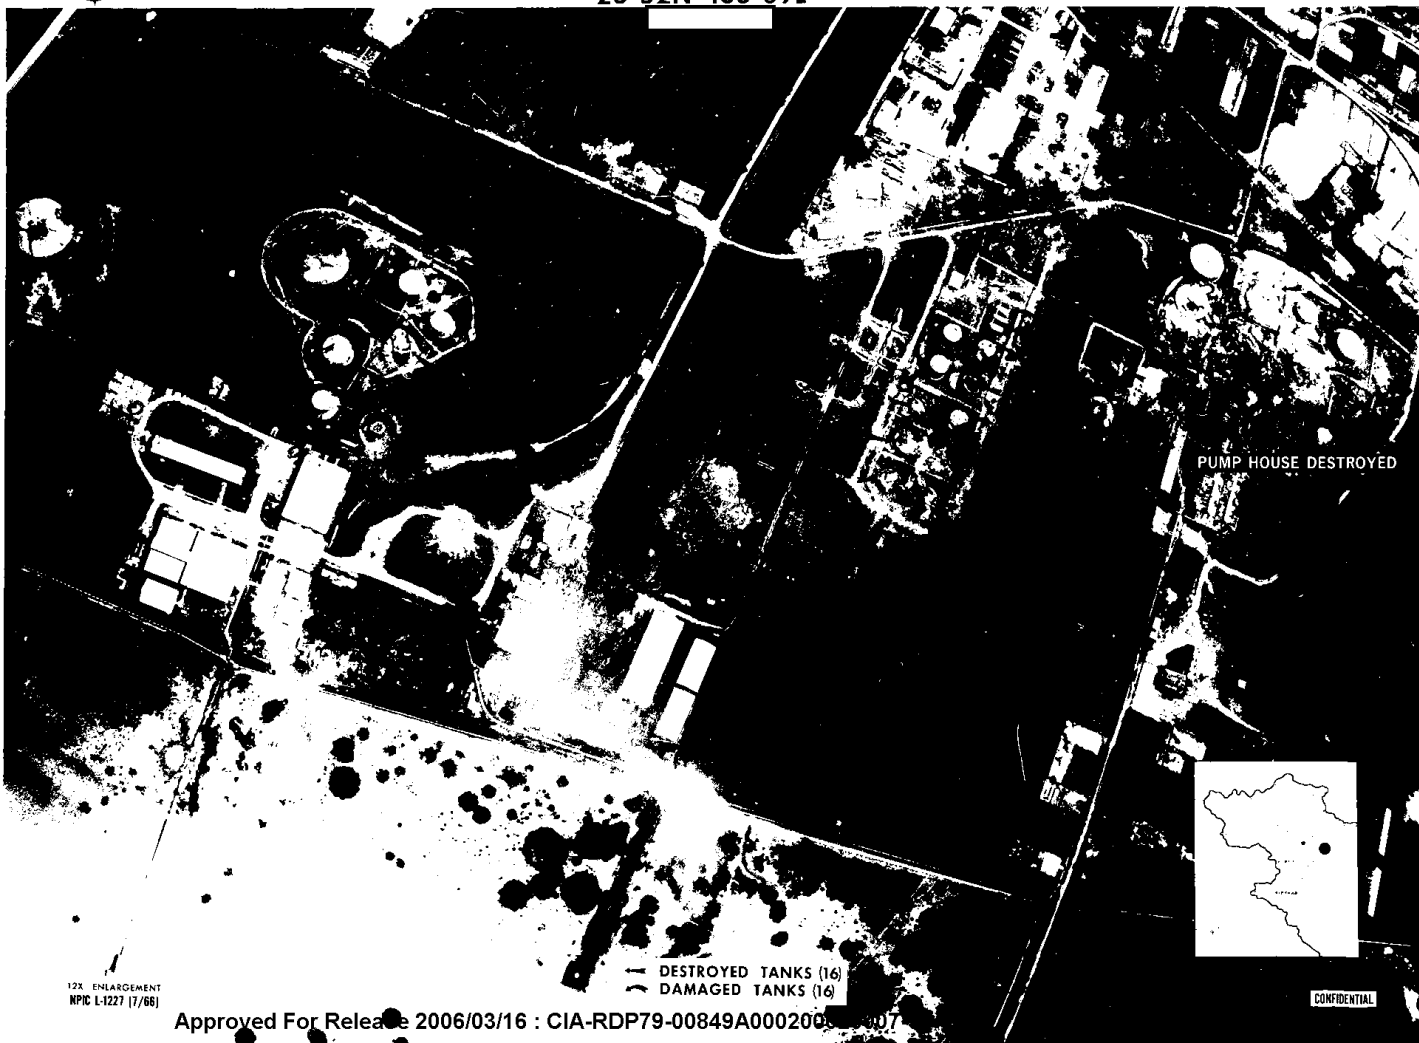
POST-STRIKE PHOTOGRAPHY [REDACTED] REVEALED EIGHT TANKS DESTROYED AND NINE TANKS DAMAGED. TWO BUILDINGS WERE OBSERVED TO BE MODERATELY DAMAGED.

STORAGE TO HAVE SUSTAINED ADDITIONAL BOMB DAMAGE FROM THE STRIKE OF
07 JULY 1966. SIXTEEN TANKS ARE NOW OBSERVED TO HAVE BEEN DESTROYED
AND SIXTEEN TANKS HAVE BEEN DAMAGED. THE PUMP HOUSE SERVING THE
WESTERN TANK AREA HAS ALSO BEEN DESTROYED. ONE SMALL HORIZONTAL
TANK DOES NOT APPEAR TO HAVE BEEN DAMAGED.
